Case Study: Safe-end Nozzle Dissimilar Metal Weld

This Case Study presents residual stress measurements carried out for this project on a Safe-End Nozzle Dissimilar Metal (DM) Weld using the Deep-Hole Drilling (DHD) technique. The DHD measurements were carried out on-site in Japan at differing stages of manufacture.

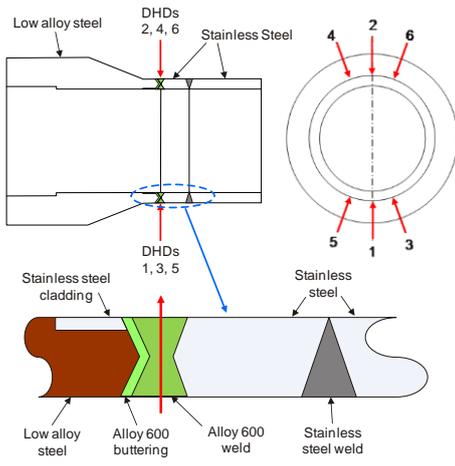
The Safe-end Nozzle comprised of a ferritic steel nozzle with a tapered outer diameter attached to a stainless steel safe-end using a double-V, nickel base alloy weld with buttering layer. The main stainless steel coolant piping was then attached using a single-V stainless steel weld. The complete Safe-end Nozzle had a tapered outer diameter ranging from 883mm to 1192mm, an inner diameter of 735mm and an overall length of roughly 1680mm.

Fig. 1: Sketch of the Safe-End Nozzle with DHD locations identified

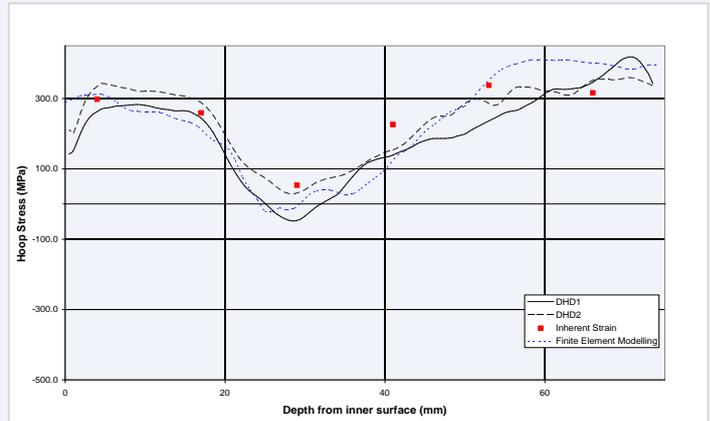
Figure 3 shows the hoop residual stresses measured and modelled after the initial stages of nozzle manufacture. It can be seen that there is excellent repeatability between the DHD measurements and excellent agreement between both measurement techniques and the finite element modelling.

Large tensile residual stresses were found at both the inner and outer surfaces of the DM weld with zero magnitude residual stresses at mid-thickness at the intersection of the double-V welds.

Fig. 3: Hoop residual stresses measured and modelled after the initial stages in manufacture

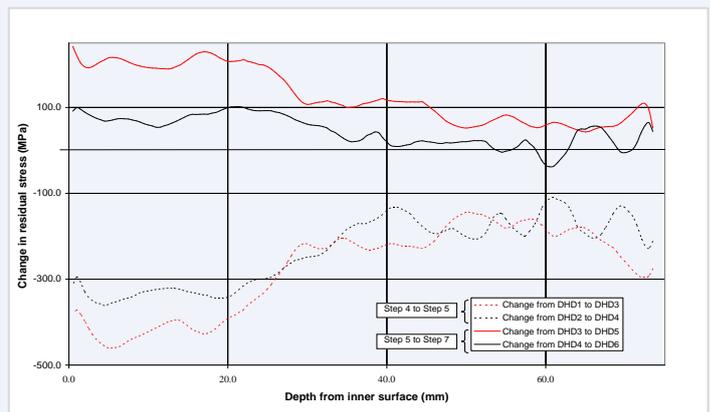
Figure 4 shows the changes in hoop residual stresses measured using the DHD technique at the different stages of manufacture.

It can be seen that the highest tensile stresses were measured in the as-welded condition (DHDs 1 & 2). Attachment of the main coolant piping with a stainless steel weld resulted in a large reduction in residual stresses, in particular towards the internal diameter where PWSCC would occur.

Fig. 4: Changes in hoop residual stresses during manufacture

Finally, the DHD measurements carried out after the second hydro-static test and the operating condition test (DHDs 5 & 6) showed increases in the hoop residual stresses. Overall, at the end of the manufacturing process, the axial residual stresses remained compressive at the inner diameter whereas the hoop stresses were approximately zero.
